REFURBISHMENT & DEMOLITION ASBESTOS SURVEY

**Cygnets House
Market Square
Staines-upon-Thames
TW18 4RH**

6th August 2015

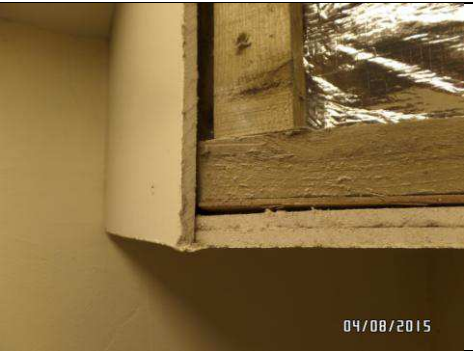
A.1.8 Sample 08	0

<p>A sample of loose ceiling tile was taken from 'spare' tiles in the basement below the electricity distribution boards.</p> <p>This sample had no asbestos detected.</p> <p>No action required</p>			<p>A sample panelling from boxwork in the basement area was taken for analysis.</p> <p>This sample had no asbestos detected.</p> <p>No action required</p>		
A.1.9 Sample 09	0

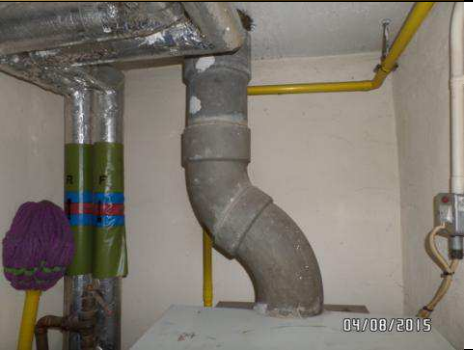
A.1.10 Sample 10	0

<p>A sample of ceiling panel in the basement was taken for analysis.</p> <p>This sample had no asbestos detected.</p> <p>No action required</p>			<p>A sample of cement boiler flue was taken for analysis.</p> <p>This sample had no asbestos detected.</p> <p>No action required</p>		
A.1.11 Sample 11	0

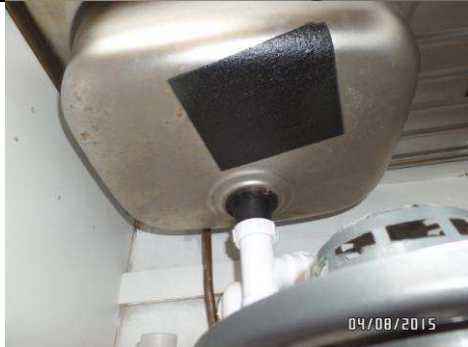
<p>A sample of sink bowl pad was taken for analysis from a first floor office.</p> <p>This sample had no asbestos detected.</p> <p>No action required</p>
